SERVICE BULLETIN

PS-50 IMPROVED VOLTAGE SURGE PROTECTION

5-23-86

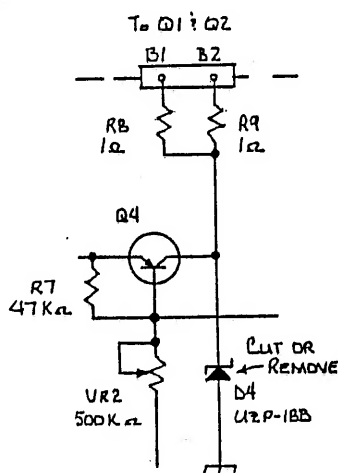
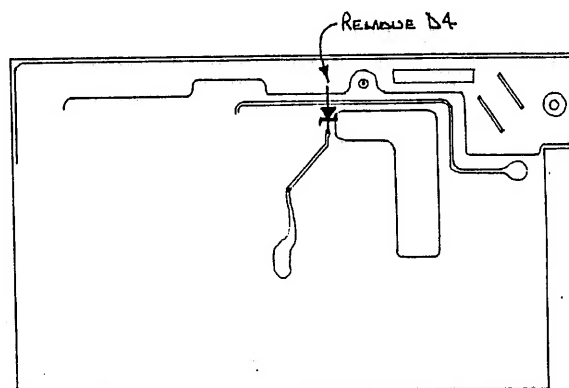
AVR UNIT (X43-1520-00) Component Side

We have received a few reports regarding the loss of transistor Q4, resistors R2, and R3, and zener diode D4 on the AVR UNIT. Apparently a voltage surge on the power input might cause D4 to short. If this occurs the surge current thru resistors R2 and R3 could be high causing the failure of the two resistors and Q4.

On the AVR UNIT (X43-1520-00) open or remove diode D4. The drawings below show the location of this component.

If you receive a unit with no output voltage check D4, R2, R3, and Q4. You should replace R2, R3, and Q4 if there is any sign of damage to any of these components.
